GA HOME INSPECTION

Inspection Report

Property Address:
3595 Sycamore Bend Decatur GA 30034

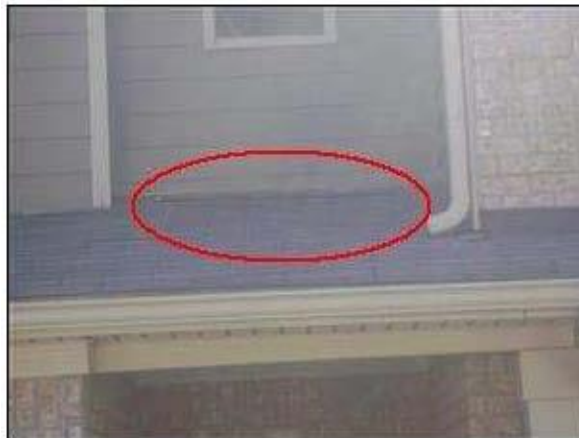
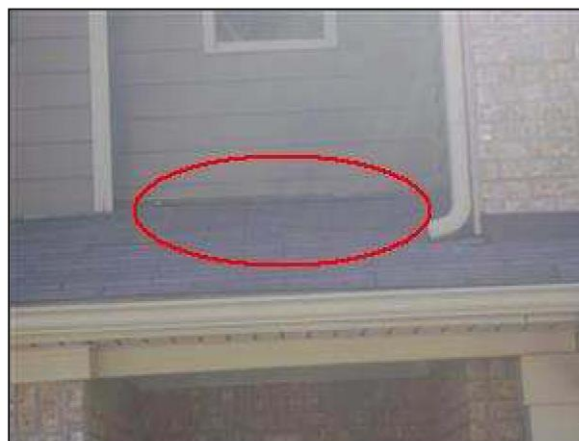
1.1 Item 1(Picture)

Comments: Inspected, Repair or Replace Need chalk on roof above front door where roof meets siding

- 1.1 FLASHINGS Inspected, Repair or Replace
Need chalk on roof above front door where roof meets siding \$25

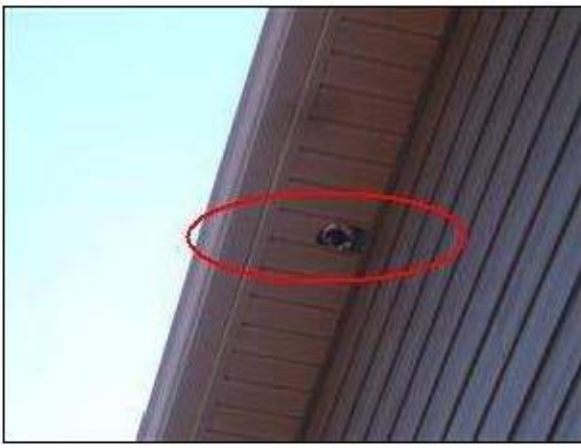
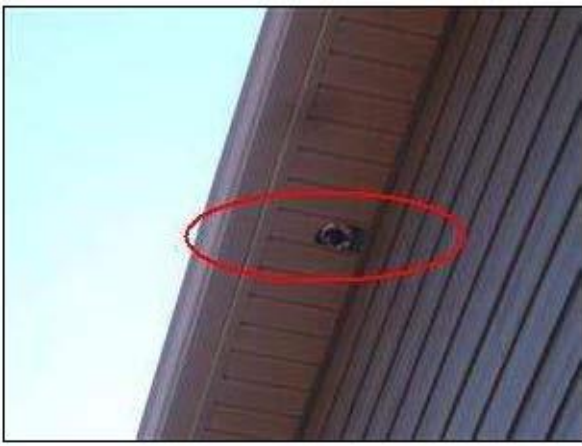
1.2 Item 1(Picture)

(1) Roof vent needs cover on left side of home.

- 1.2 SKYLIGHTS, CHIMNEYS AND ROOF PENETRATIONS Inspected, Repair or Replace
(1) Roof vent needs cover on left side of home. \$25

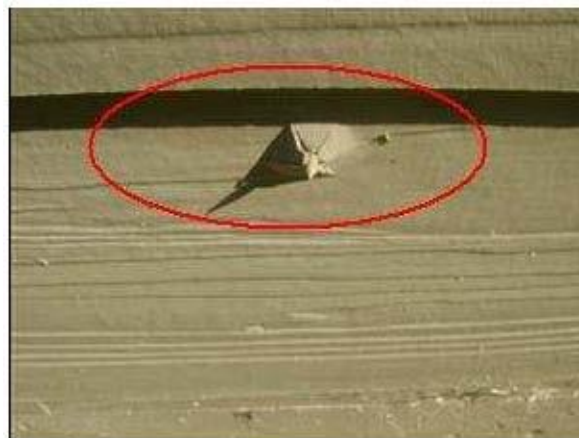
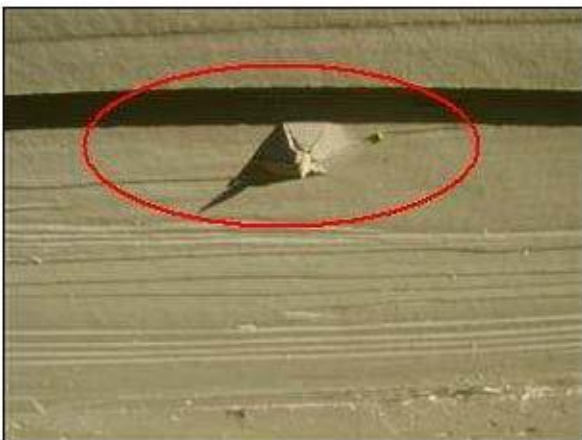
2.0 Item 1(Picture)

Comments: Inspected, Repair or Replace Remove nail that is protruding from right side of home.

Remove nail that is protruding from right side of home.
\$0

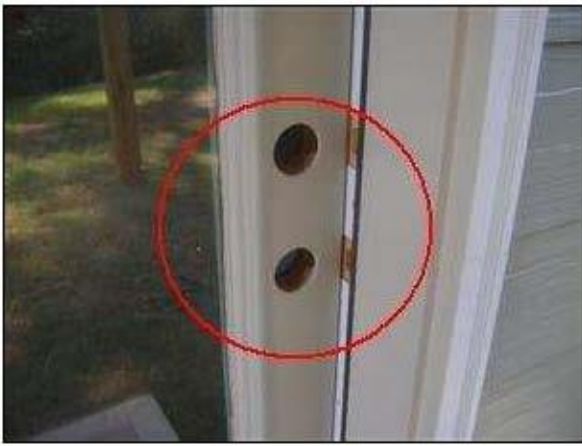
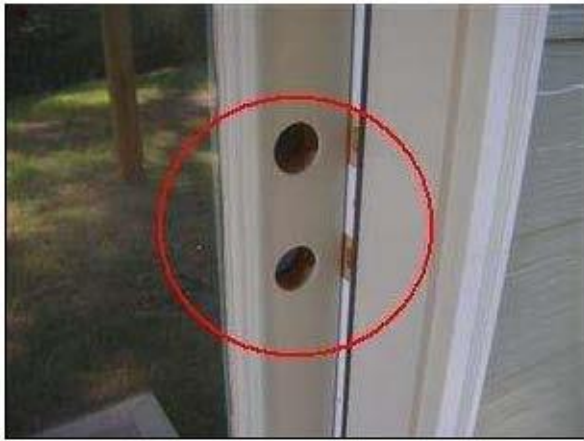
2.1 Item 1(Picture)

Comments: Inspected, Repair or Replace Need lock on basement door.

- 2.1 DOORS (Exterior) Inspected, Repair or Replace
Need lock on basement door. \$25 -\$50

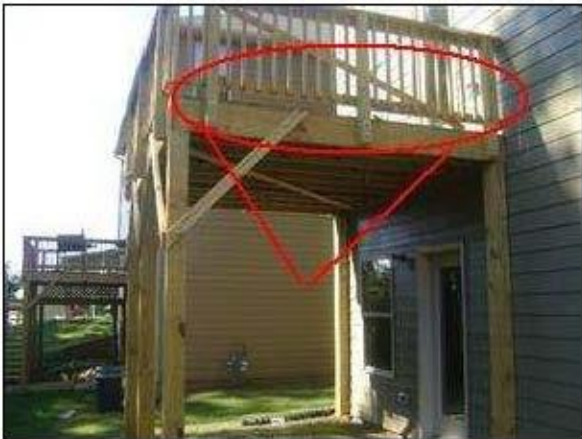
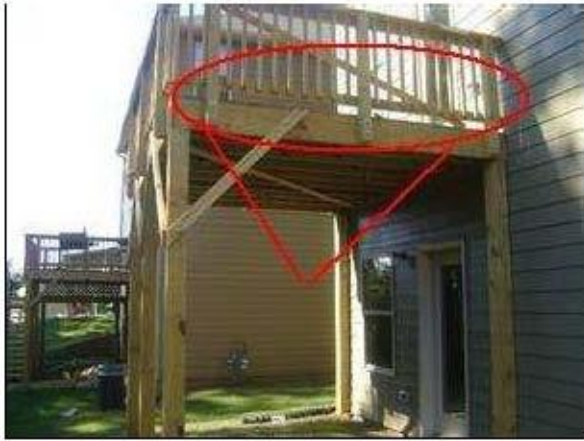
2.3 Item 1(Picture)

(1) Recommend weather proofing wooden deck with seal or stain.

- 2.3 DECKS, BALCONIES, STOOPS, STEPS, AREAWAYS, PORCHES, PATIO/ COVER AND APPLICABLE RAILINGS
Inspected, Repair or Replace
(1) Recommend weather proofing wooden deck with seal or stain.\$100 -\$150

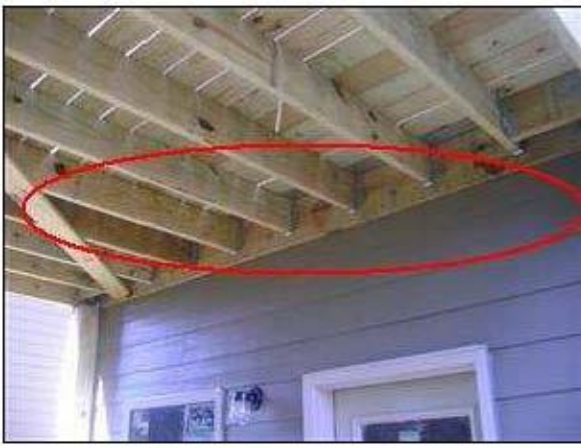
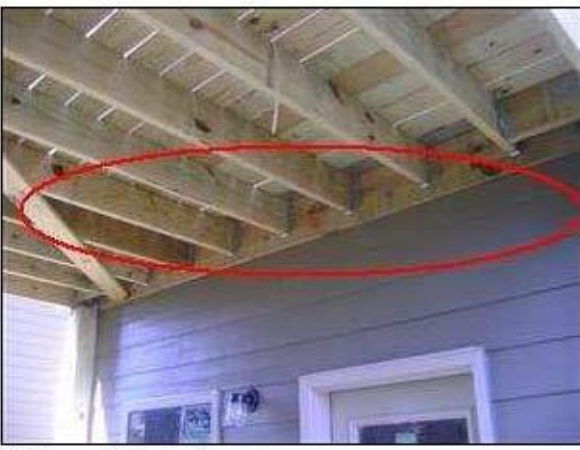
2.3 Item 3(Picture)

(3) Deck structure

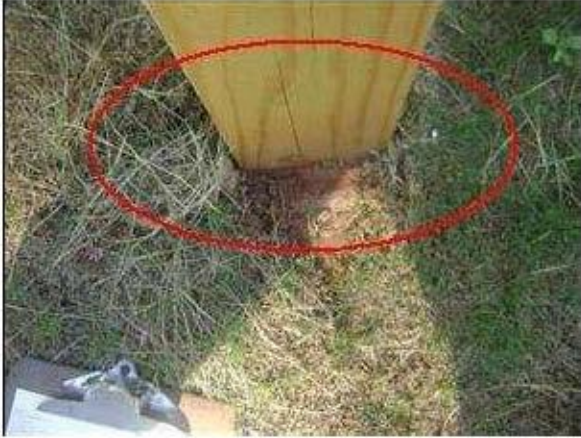
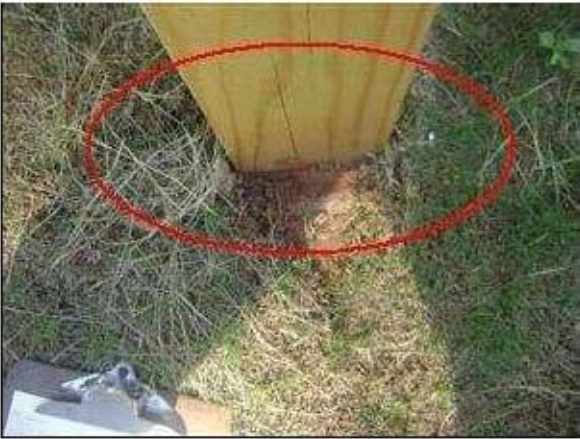
2.3 Item 4(Picture)

(4) Deck post

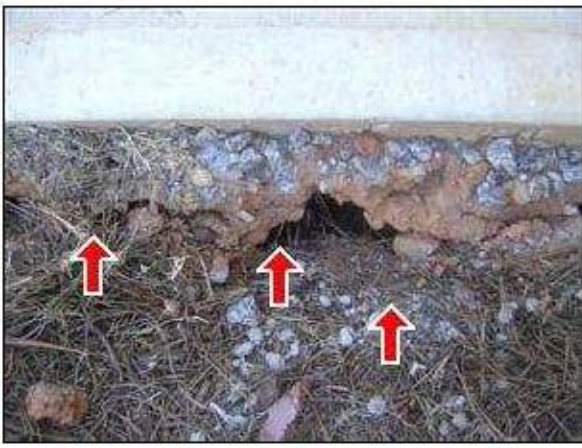
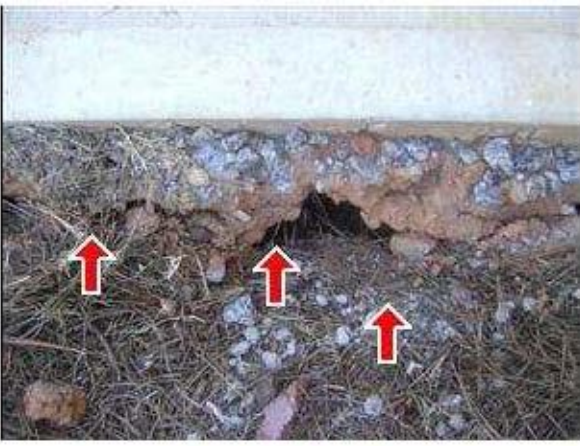
2.4 Item 2(Picture)

(2) Hole under front pad

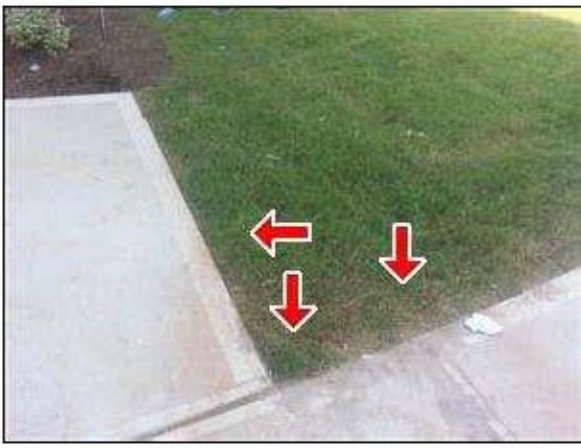
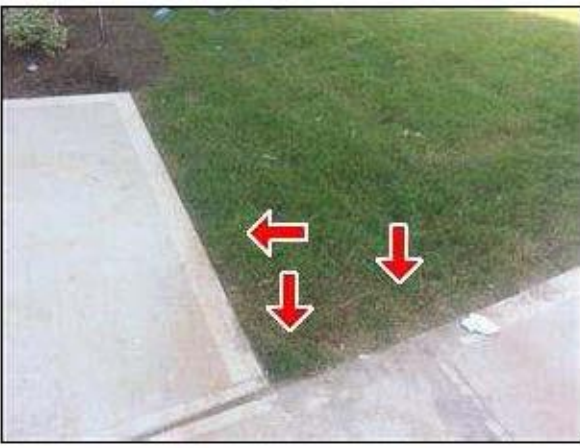
2.4 Item 5(Picture)

(5) There is a downward grading of front concrete pad that would appear that water may puddle in this area. Would consider testing area and installing drain if water puddles.

(5) There is a downward grading of front concrete pad that would appear that water may puddle in this area. Would consider testing area and installing drain if water puddles. \$10 -\$150

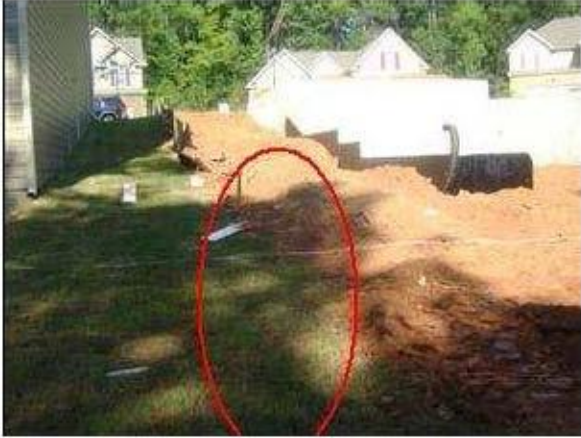
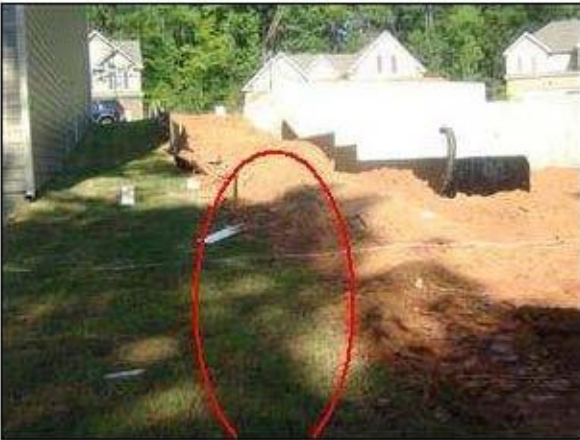
2.4 Item 6(Picture)

(6) Recommend installing silt fence on left side of yard to end of property line.

(6) Recommend installing silt fence on left side of yard to end of property line. \$25

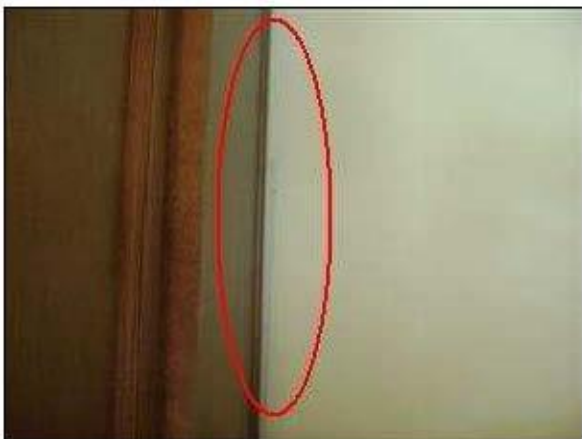
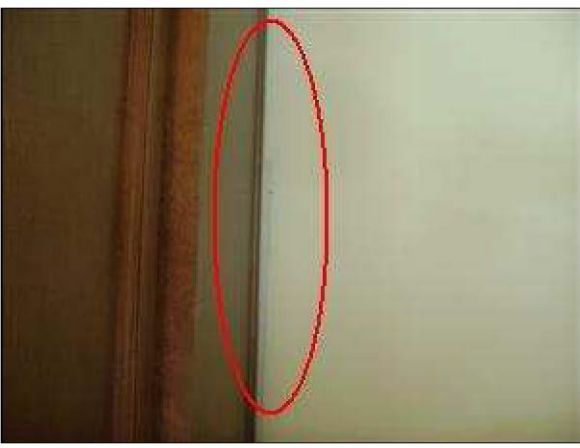
4.1 Item 1(Picture)

(1) Wall on right side of cabinet over refrigerator needs to be painted.

(1) Wall on right side of cabinet over refrigerator needs to be painted. \$20

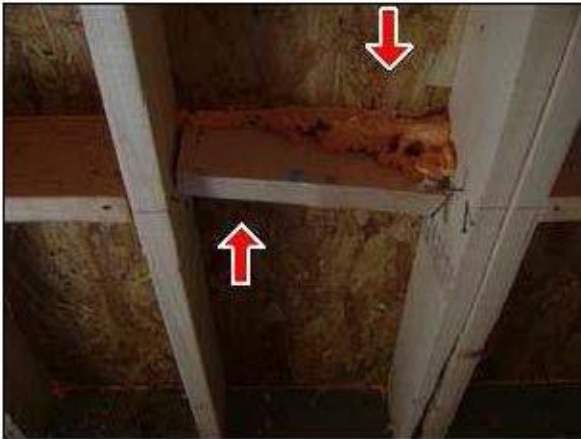
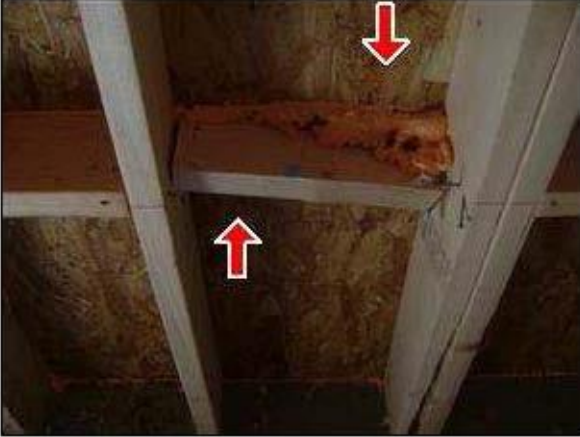
4.1 Item 2(Picture)

(2) Support cross stud needs to be better supported or re-attached.

(2) Support cross stud needs to be better supported or re-attached. \$20

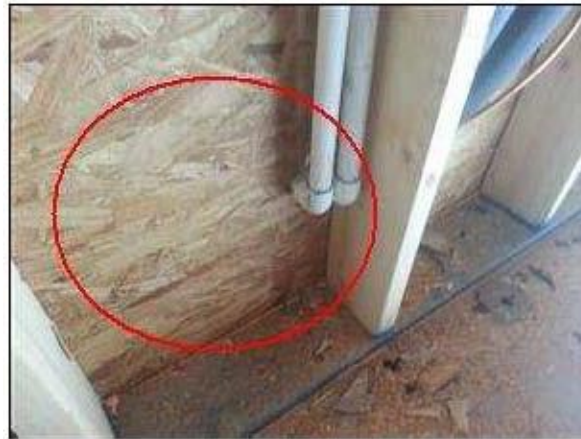
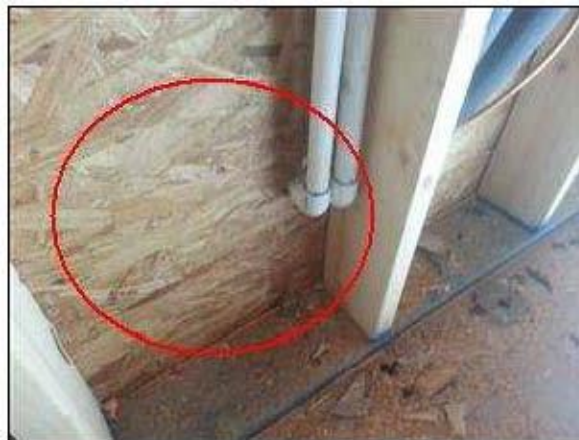
4.1 Item 3(Picture)

(3) Recommend spray insulation around condenser lines in basement coming into home.

(3) Recommend spray insulation around condenser lines in basement coming into home. \$25

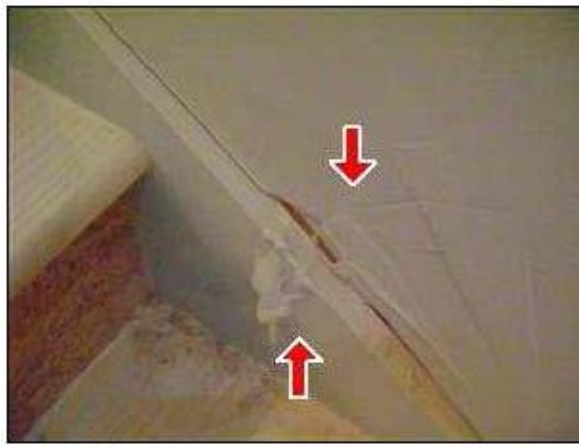
4.1 Item 5(Picture)

(5) There is a gap in wall along basement stairs in 2 places.

(5) There is a gap in wall along basement stairs in 2 places. \$25

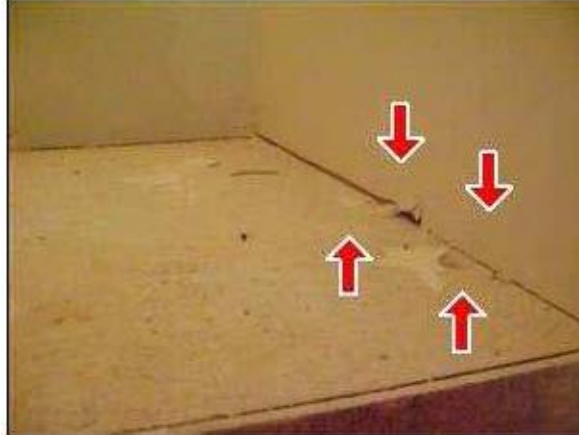
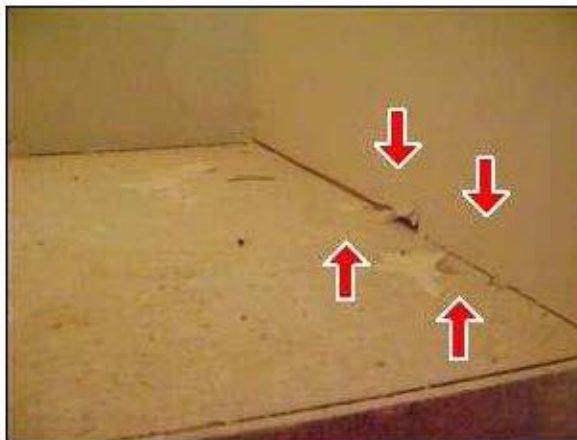
4.1 Item 6(Picture)

(6) There is a gap in wall along basement stairs in 2 places.

(6) There is a gap in wall along basement stairs in 2 places. \$25

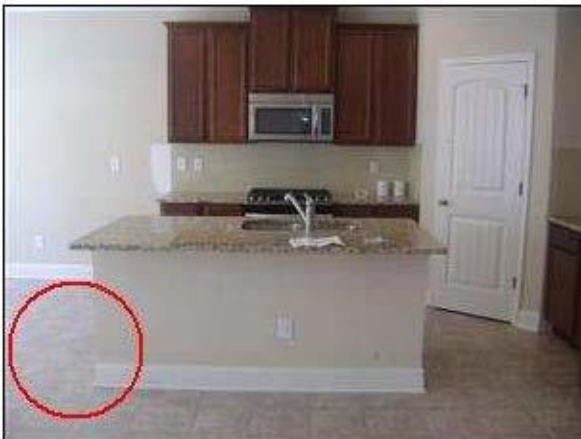
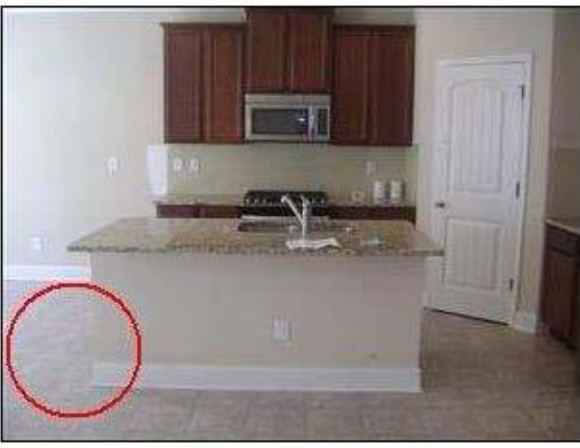
4.2 Item 1(Picture)

(1) Floor under kitchen island needs to be better supported so island does not move when walking past it.

(1) Floor under kitchen island needs to be better supported so island does not move when walking past it. \$50-\$75

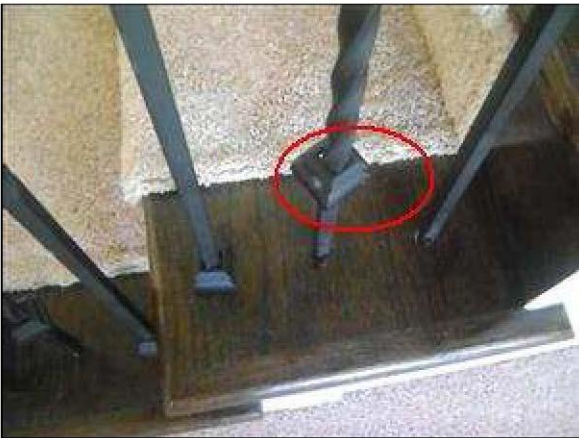
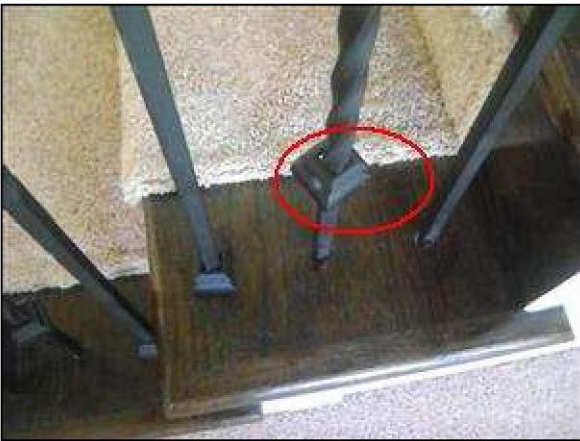
4.3 Item 1(Picture)

Comments: Inspected, Repair or Replace Bottom of some wrought iron stair pickets need to be lowered and affixed.

4.3 STEPS, STAIRWAYS, BALCONIES AND RAILINGS Inspected, Repair or Replace
Bottom of some wrought iron stair pickets need to be lowered and affixed. \$20

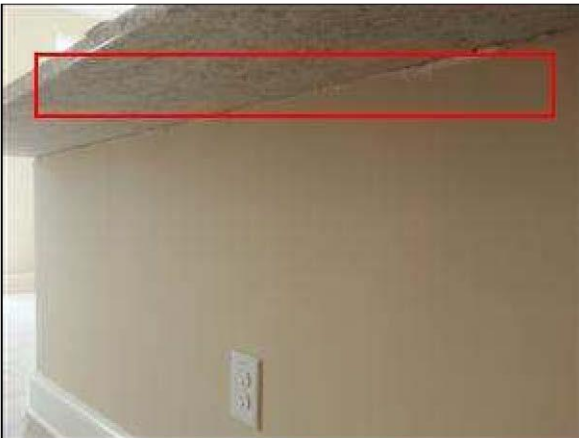
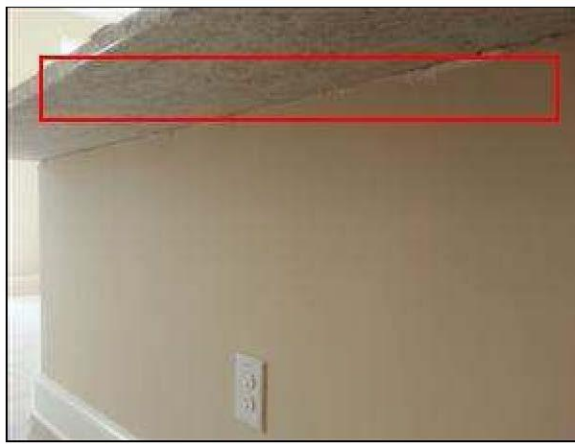
4.4 Item 1(Picture)

Comments: Inspected, Repair or Replace Need trim or molding between counter and island

4.4 COUNTERS AND A REPRESENTATIVE NUMBER OF CABINETS Inspected, Repair or Replace
Need trim or molding between counter and island \$75-\$100

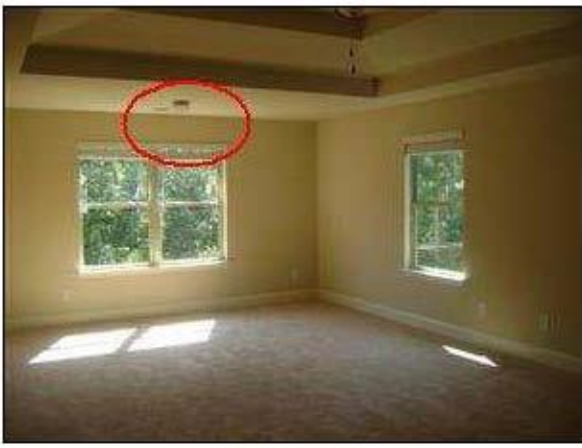
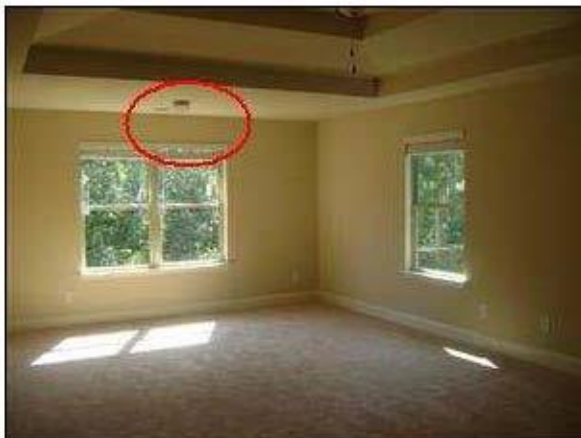
7.3 Item 1(Picture)

(1) Light fixture in M bedroom is loose.

- 7.3 CONNECTED DEVICES AND FIXTURES (Observed from a representative number operation of ceiling fans, lighting fixtures, switches and receptacles located inside the house, garage, and on the dwelling's exterior walls)
Inspected, Repair or Replace
(1) Light fixture in M bedroom is loose.\$20

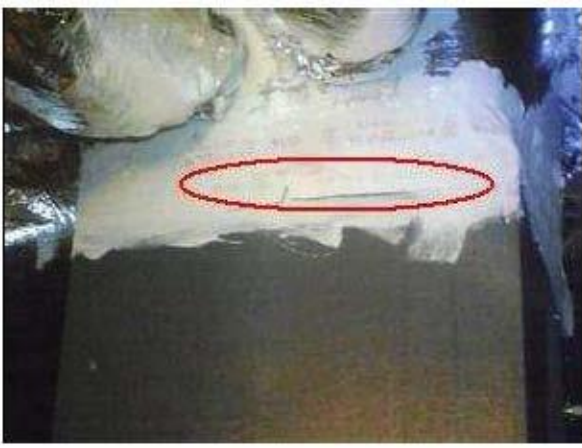
8.3 Item 1(Picture)

Duct tape needs to be affixed to furnace to prevent leakage.

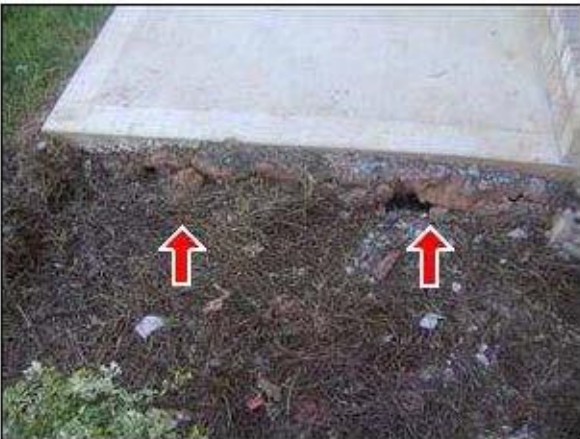
2.4 Item 1(Picture)

(1) Front are needs to be back filled with dirt and leveled off. Pine straw to be applied afterward to prevent further soil erosion. \$101 -\$250

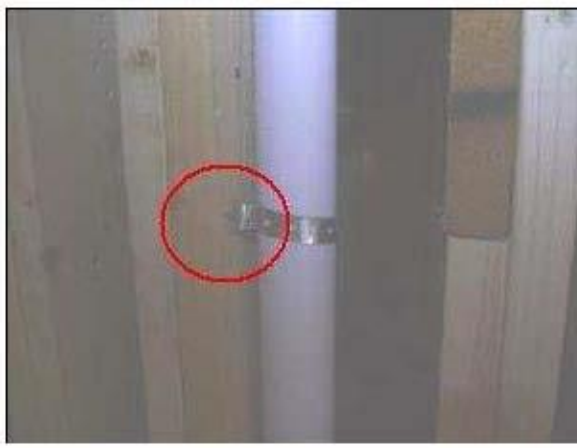
4.1 Item 4(Picture)

(4) Strap around PVC pipe in basement needs to be tightened. \$20

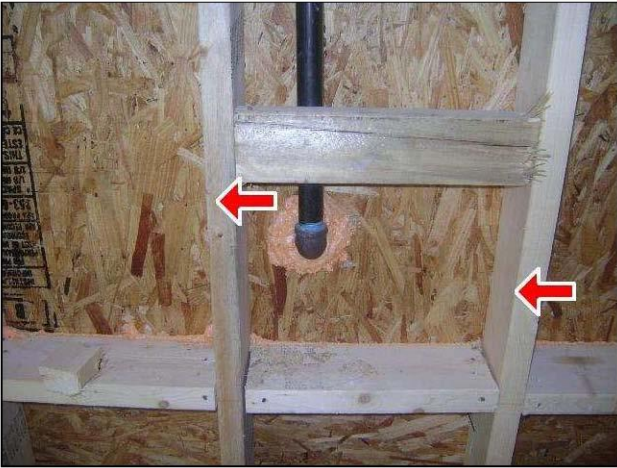
4.2 Item 2(Picture)

(2) There are 2 spots in basement floor joists where insulation is missing.

(2) There are 2 spots in basement floor joists where insulation is missing. \$25

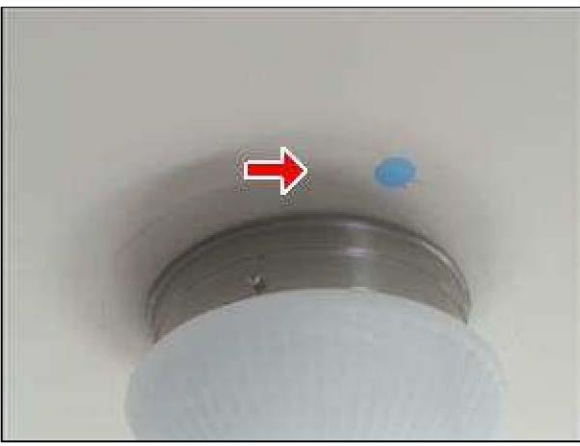
7.3 Item 2(Picture)

- (2) M bed light \$0
